INVENTORY OF MONUMENTS AT PAGAN

Volume One
Monuments 1-255

PIERRE PICHARD

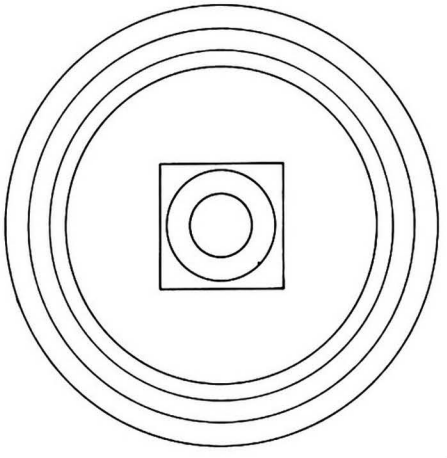
interior :

shrine :
- under vault, carved figures in square recesses.
- carved bases of pillars.

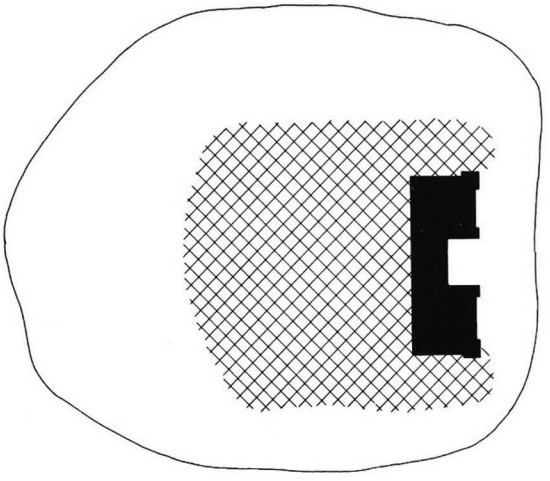
8 epigraphy
- 1 stone slab, prepared and polished but without inscription, 66 x 12, height = 96 cm.

158
(126b)

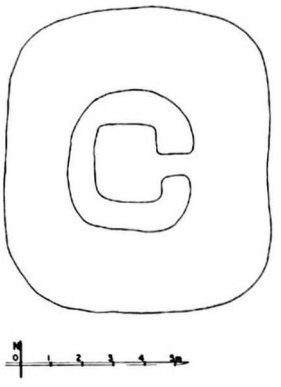
(127) ကျောင်းဦးဘုရား

159 a - Plan

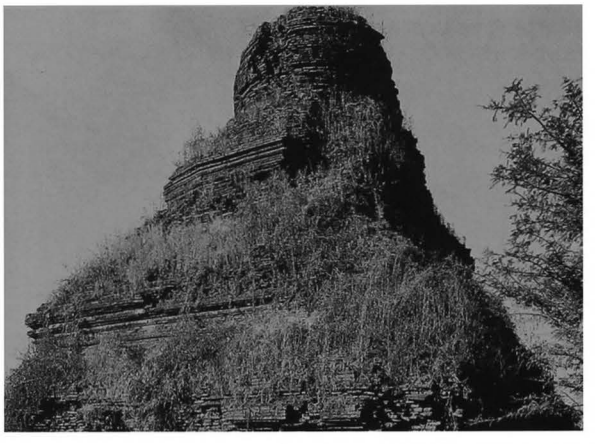
1449 d - East face, from north-east

5 present condition
- no maintenance.
- north side disintegrated.
- upper parts badly damaged.

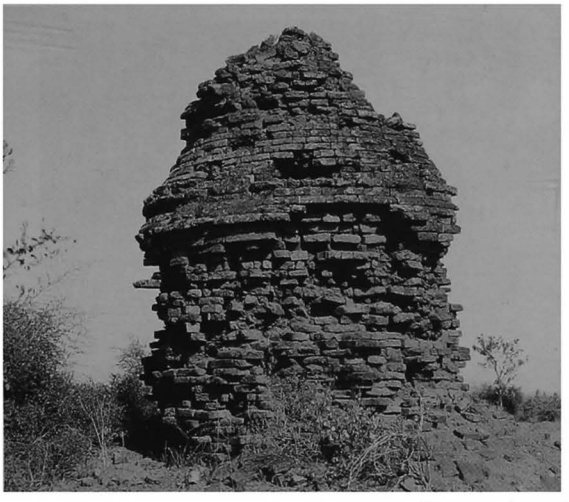
1450 b - From north-west

5 present condition
- ruined.
- terraces disintegrated.
- upper parts nearly destroyed.

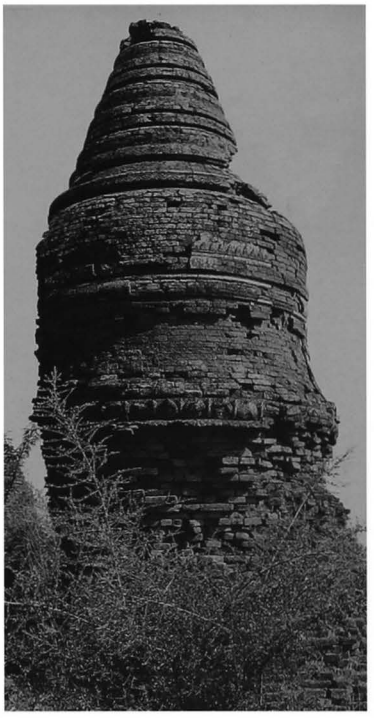
1453 b - From north

5 present condition
- half-ruined.
- terraces disintegrated.
- upper parts badly damaged.

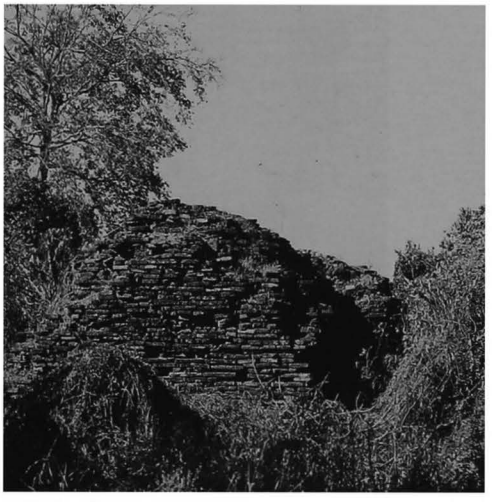
1454 b - From south-east

5 present condition
- ruined.
- vaults and upper parts collapsed.
- ground floor buried under debris.

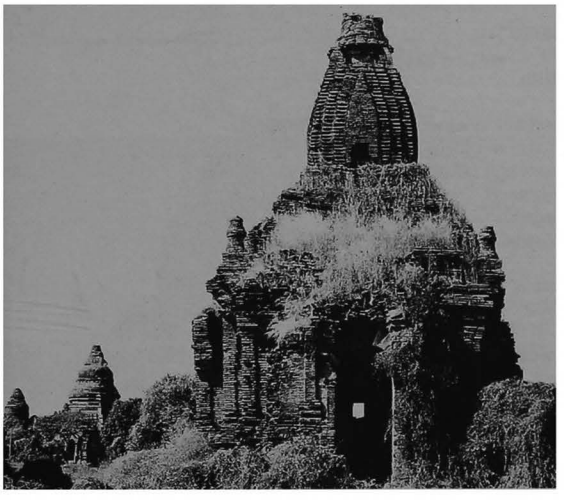
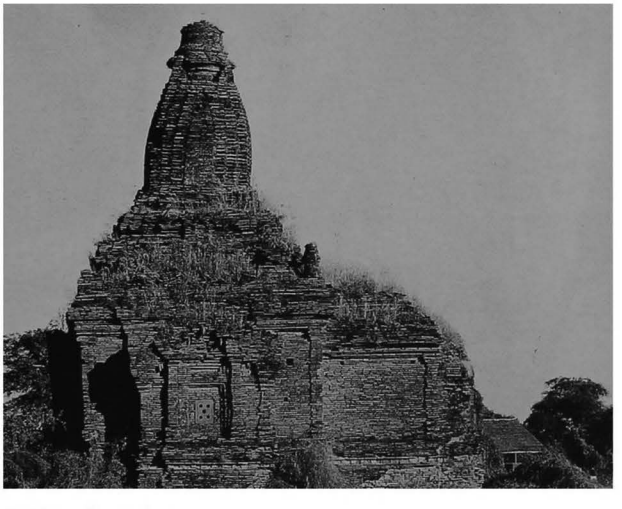
1462 c - South face

5 present condition
- no maintenance.
- base disintegrating.
- upper parts damaged, tower leaning eastwards.
- structure badly cracked.

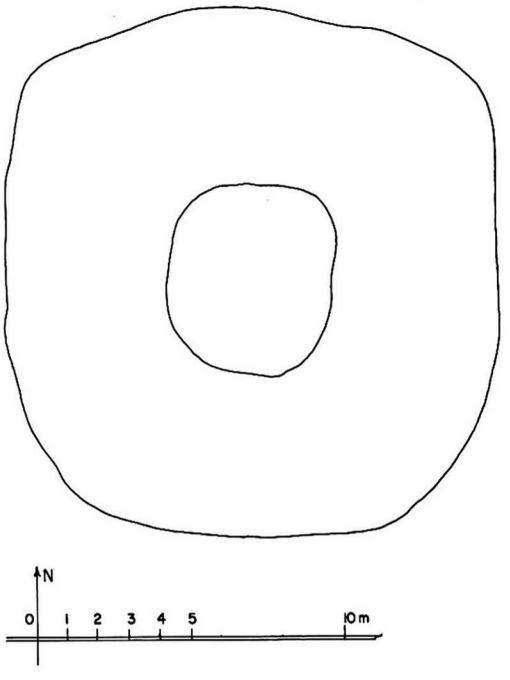
1466 a - Plan

5 present condition
- brick debris.
- height: approx. 1.60 m.

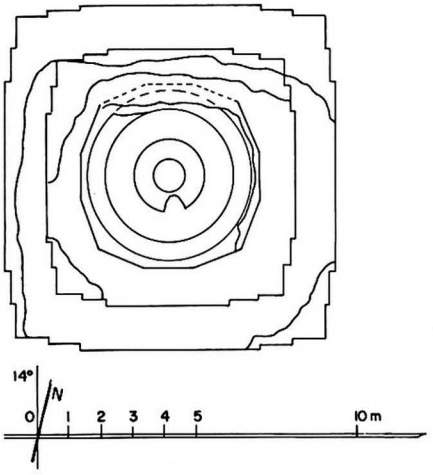
1468 a - Plan

5 present condition
- no maintenance.
- terraces damaged.
- upper parts disintegrating.

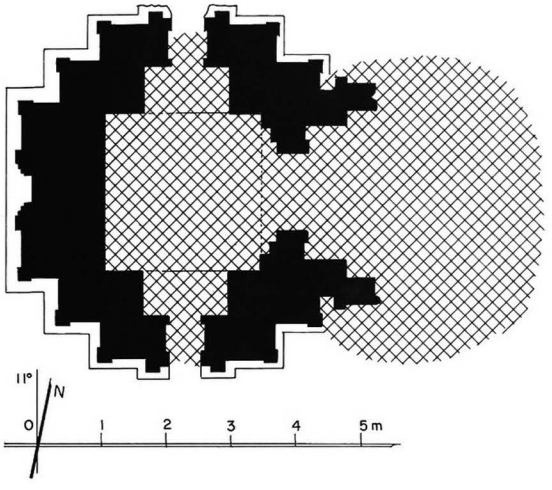
1470 a - Plan

5 present condition
- ruined.
- vaults and upper parts collapsed.
- ground floor buried under debris.

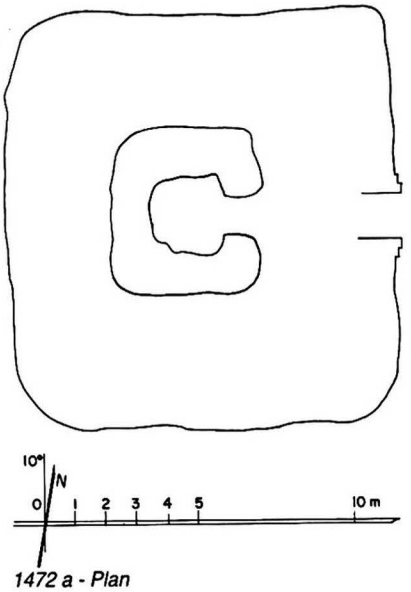
1472 a - Plan

5 present condition
- ground floor buried under debris.
- height: approx. 3.80 m.

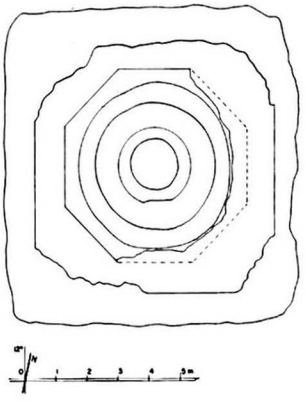
1474 a - Plan

5 present condition
- no maintenance.
- base and terraces disintegrated.
- upper parts badly damaged.

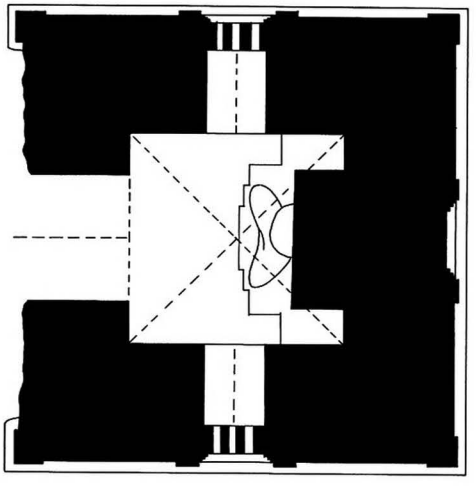
1475 a - Plan

5 present condition
- structure badly cracked.
- base disintegrated.
- east porch collapsed.
- upper parts damaged.
- repaired (Arch. Dept.) 1993.

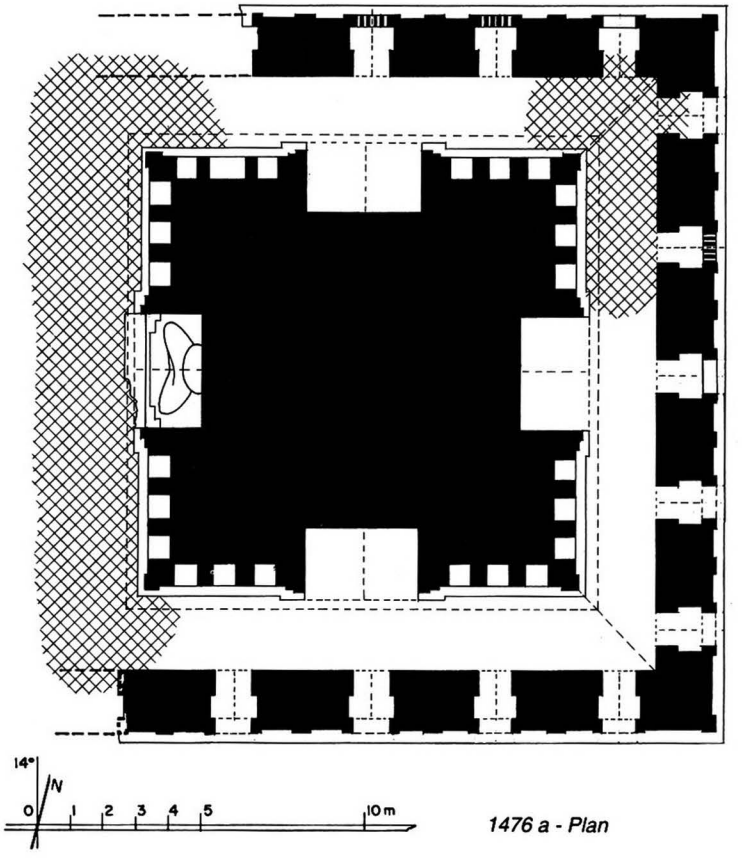
1476 a - Plan

5 present condition
- no maintenance.
- west side totally destroyed, down to foundations.
- corridor vault collapsed except on south-east corner.
- ground floor partly buried under debris.

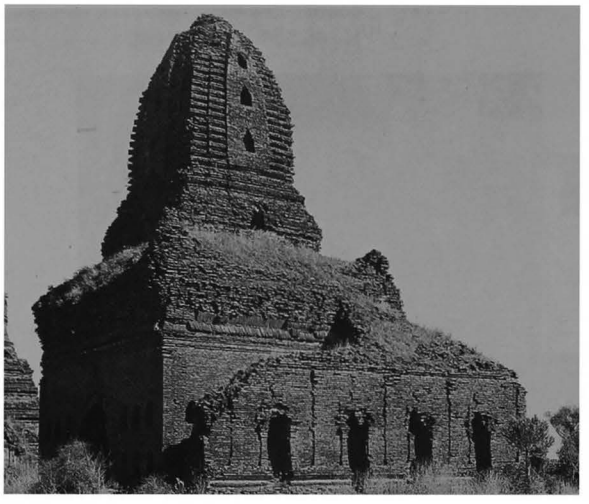
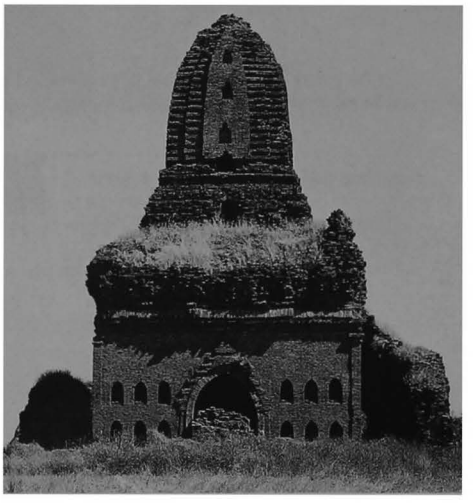
1476 c - From south-west

remark
- the west part has completely vanished, including its foundations. The whole outer wall and corridor of temple **1497** and of **1600 Nat-hlaung-kyaung** apparently met the same fate, possibly, according to legend, to use their bricks to strengthen the nearby city wall when the Mongol army was approaching Pagan in 1284-87.

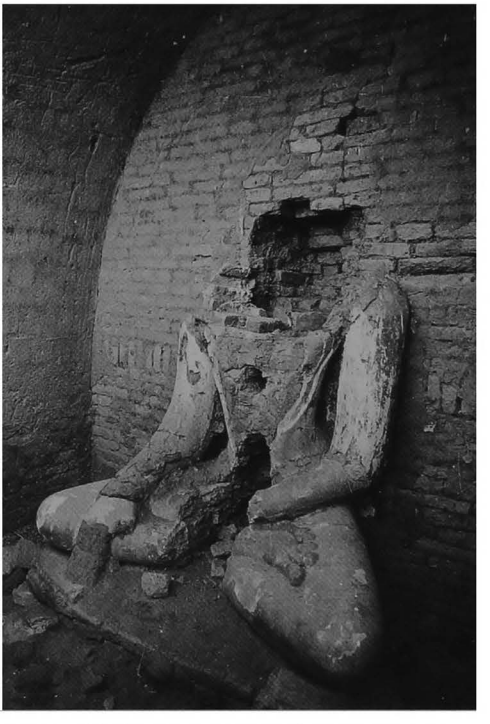
1476 k - West niche and image, from south-west

6 image
- 1 seated Buddha, facing west (damaged and headless).

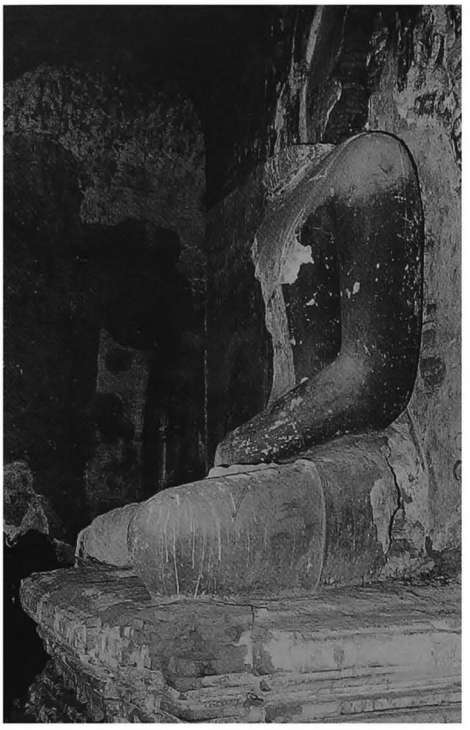
1478 n - Ground floor, west image, from south

6 images
ground floor:
- 2 seated Buddhas, facing west and east (damaged and headless).

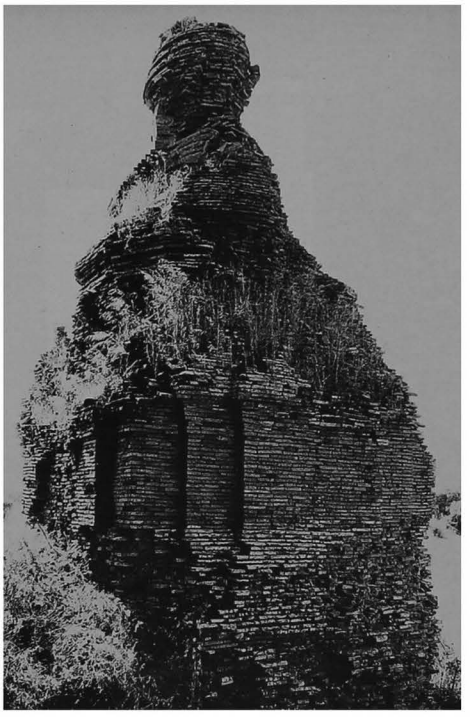
1484 b - North face, from north-east

5 present condition
- half-ruined and endangered.
- base and terraces disintegrated.
- upper parts badly damaged.

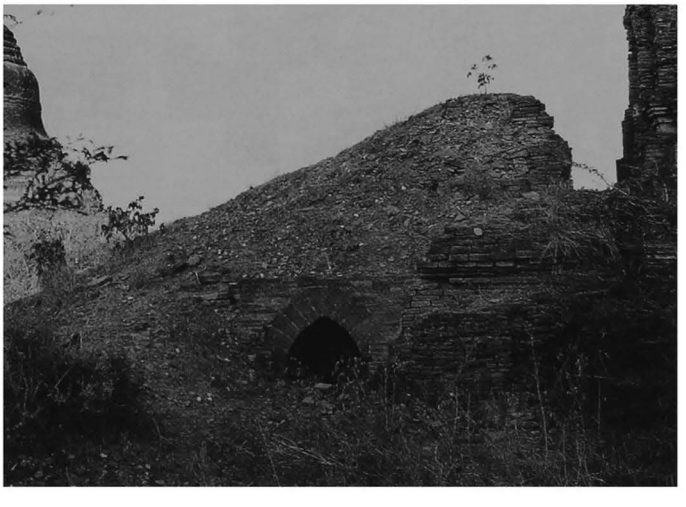
1485 b - West face

5 present condition
- ruined.
- ground floor buried under debris.
- present height: 1.20 m above patform.

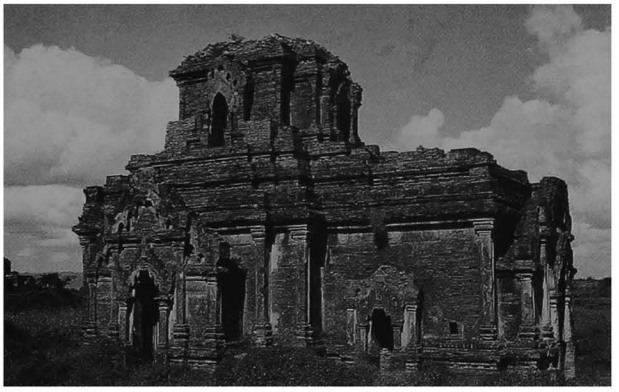
1486 b - South face, from south-east (1975)

5 present condition
- maintained.
- upper terraces and tower collapsed in the 1975 earthquake, reconstructed 1982.

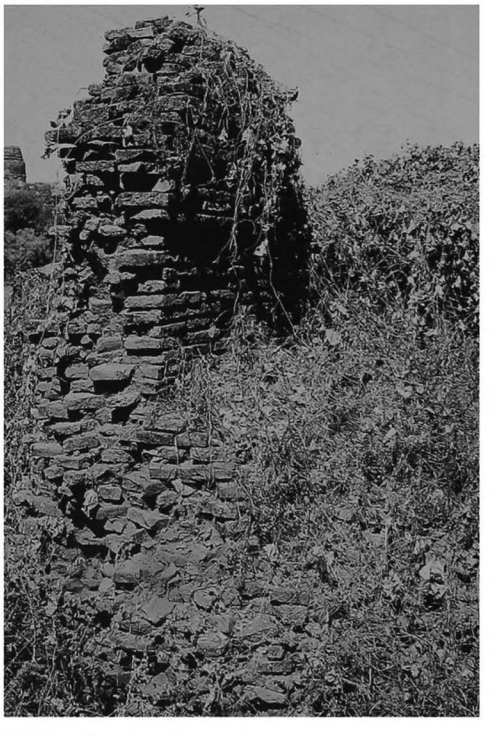
1488 b - From east

5 present condition
- ruined.
- only part of west face remains.
- height: approx. 2.70 m.

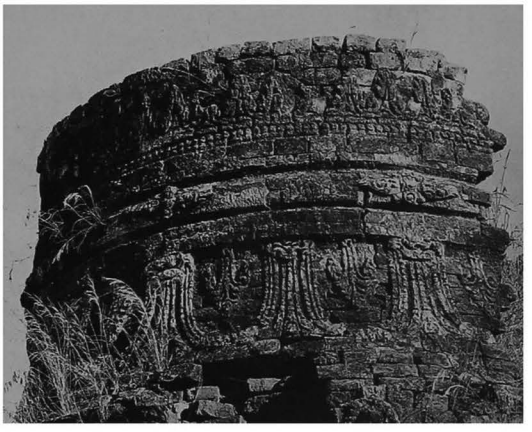
1491 b - Dome, detail from south

5 present condition
- half-ruined.
- base and terraces disintegrated.
- upper parts nearly destroyed.

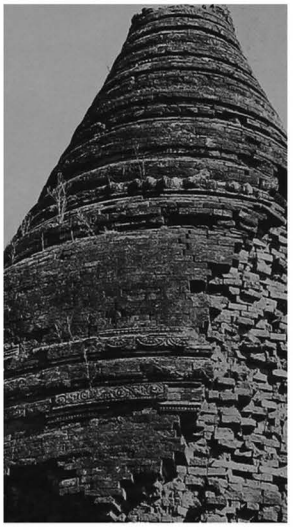
1492 b - Upper parts, detail from south-west

5 present condition
- half-ruined.
- terraces disintegrated.
- upper parts badly damaged.

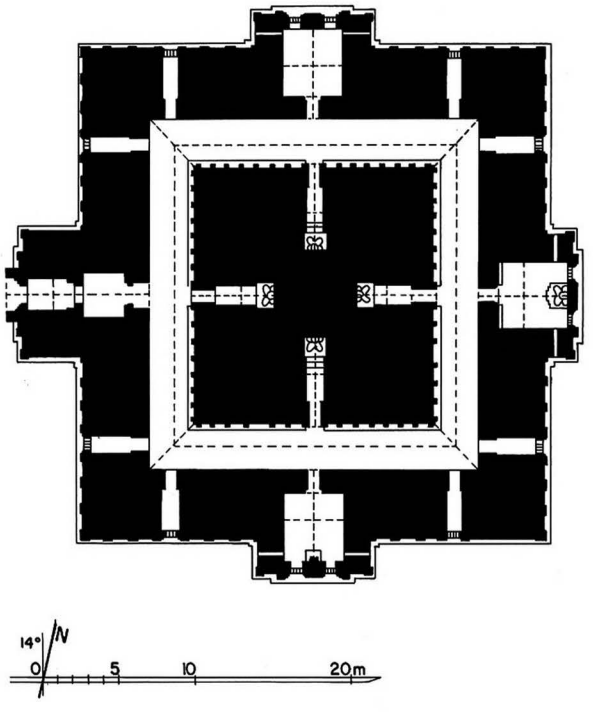
1493 a - Plan

5 present condition
- regularly maintained.
- spire damaged by the 1975 earthquake.
- repaired (Arch. Dept.) 1978.

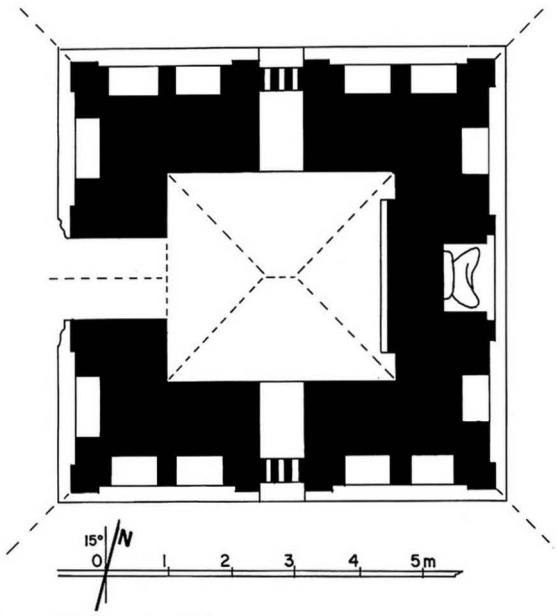
1497 a - Plan

5 present condition
- half-ruined.
- vault and outer wall of corridor collapsed.
- upper parts destroyed.

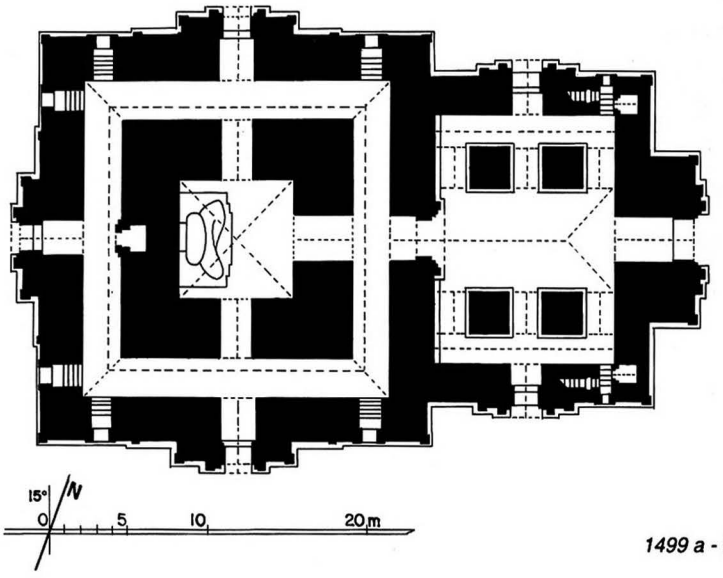
1499 a - Plan

5 present condition
- regularly maintained.
- repaired (Arch. Dept.) 1976-1978.

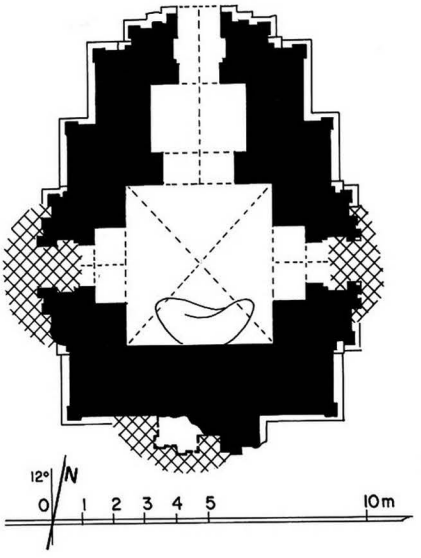
1500 a - Plan

5 present condition
- ruined.
- vaults and upper parts collapsed.

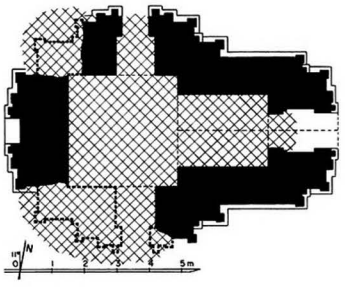
1501 a - Plan

5 present condition
- ruined.
- vaults and upper parts collapsed.
- structure badly cracked.
- ground floor buried under debris.

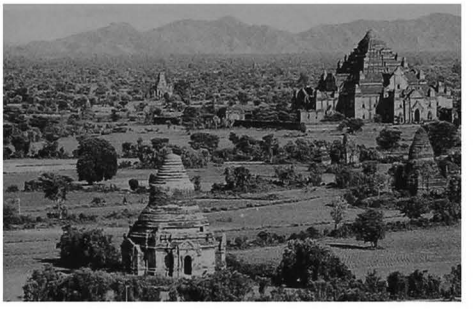
1504 c - North-east face, under repair (1982)

1504 d - From north-east (1983), after repair

5 present condition
- regularly maintained.
- repaired (Arch. Dept.) 1982-83.
- brick grilles built by Arch. Dept.

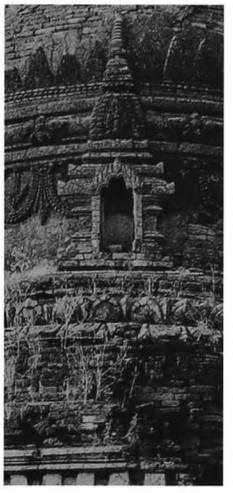
1507 c - Dome, detail of south niche

5 present condition
- west face badly damaged.
- east porch collapsed.
- repaired (Arch. Dept.).

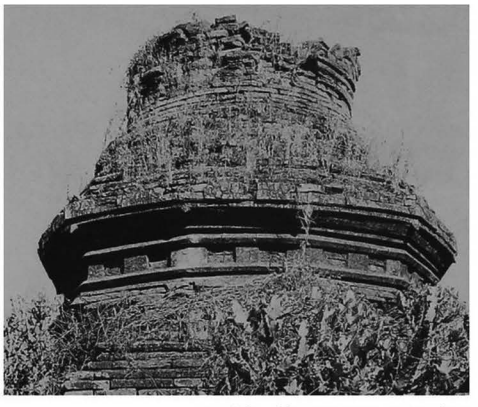
1510 b - Upper parts, west face

5 present condition
- half-ruined.
- base and terraces disintegrated.
- upper parts badly damaged.

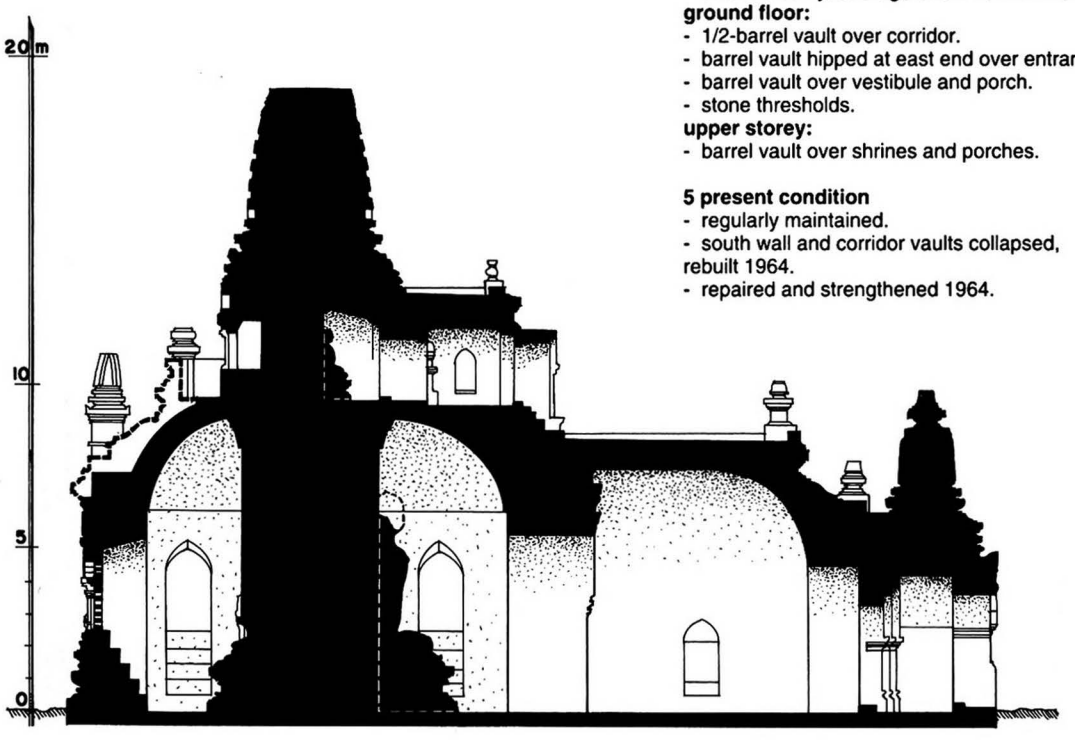
1512 a3 - Longitudinal section

5 present condition
- regularly maintained.
- south wall and corridor vaults collapsed, rebuilt 1964.
- repaired and strengthened 1964.

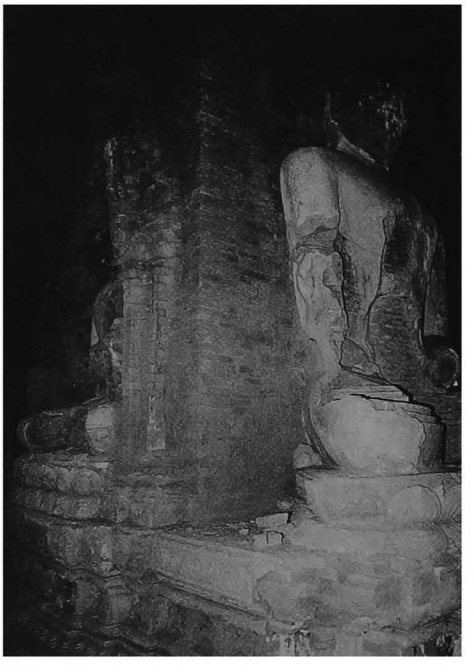
1512 p - Core, east and south images, from south-east

6 images
ground floor:
- 1 seated Buddha, facing east (damaged and headless).
- 1 seated Buddha, preaching (dharmacakra mudra), facing south (damaged and headless).
- 1 reclining Buddha, facing west (damaged and headless).
- 1 Buddha's Nativity in north niche of core (badly damaged).

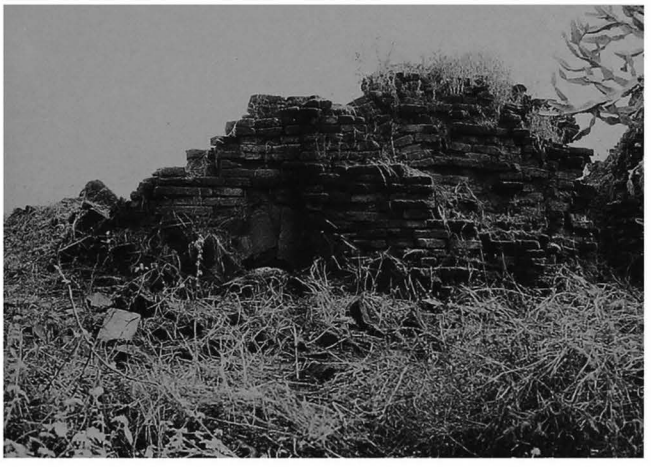
5 present condition
- ruined.
- vaults and upper parts collapsed.
- ground floor buried under debris.

1515 d - Vestibule, south-west corner, from west

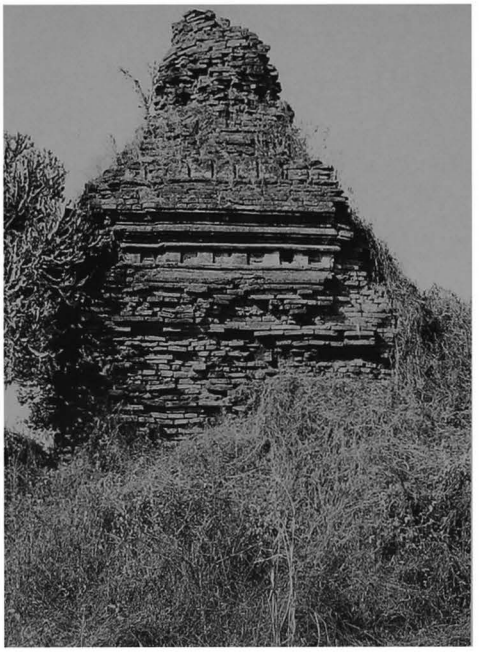
5 present condition
- half-ruined.
- base and terraces disintegrated.
- upper parts nearly destroyed.

1516 b - East face

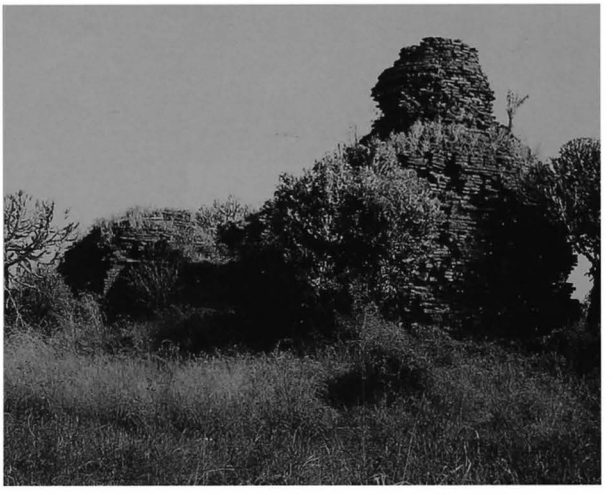
1516 c - From south-west, together with 1515

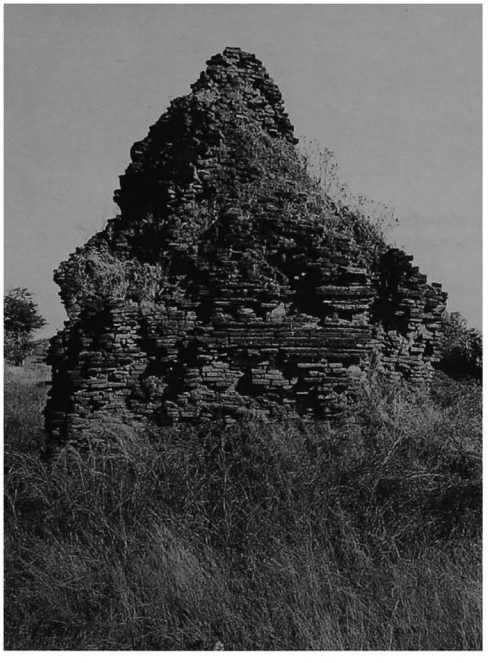
5 present condition
- half-ruined.
- base and terraces disintegrated.
- upper parts nearly destroyed.

1517 b - South face

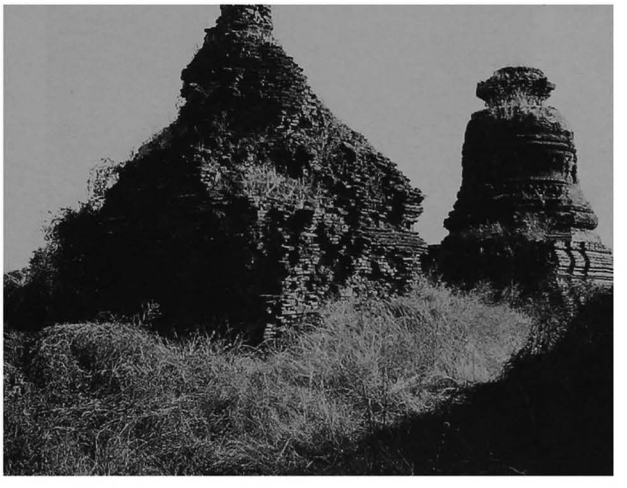
1517 c - From south-west, together with 1518

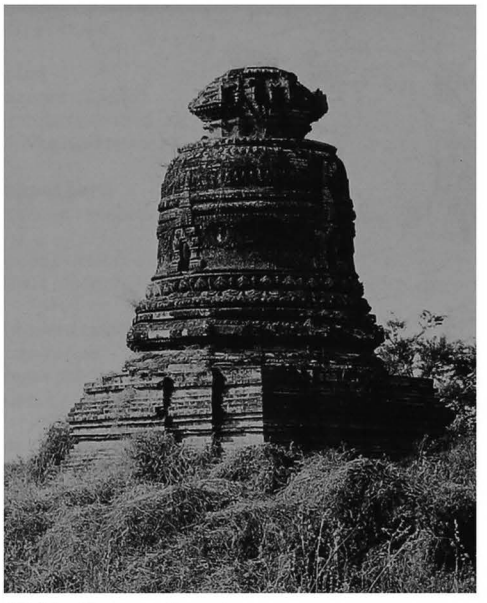
1518 b - From north-east

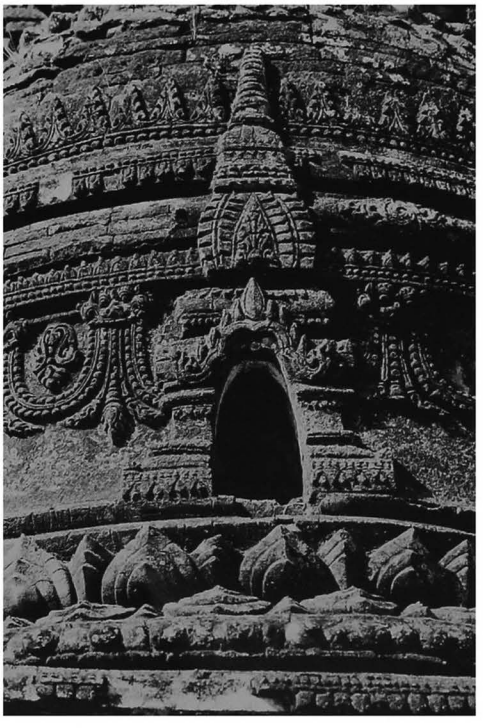
1518 c - Dome, east niche, from east

5 present condition
- terraces repaired (Arch. Dept.) 1966.

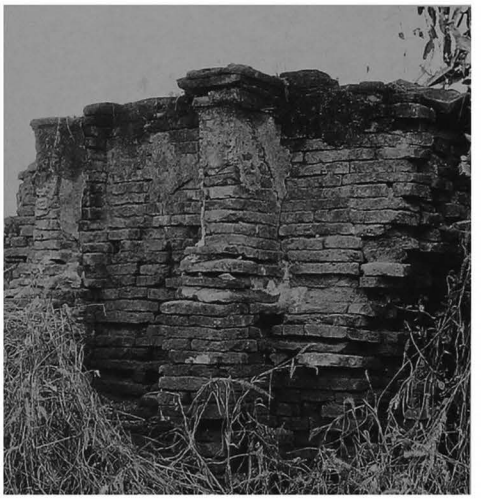
5 present condition
- ruined.
- only base of walls remains.
- present height 1.80 m.
- ground floor buried under debris.

1522 d - West face, from south-west

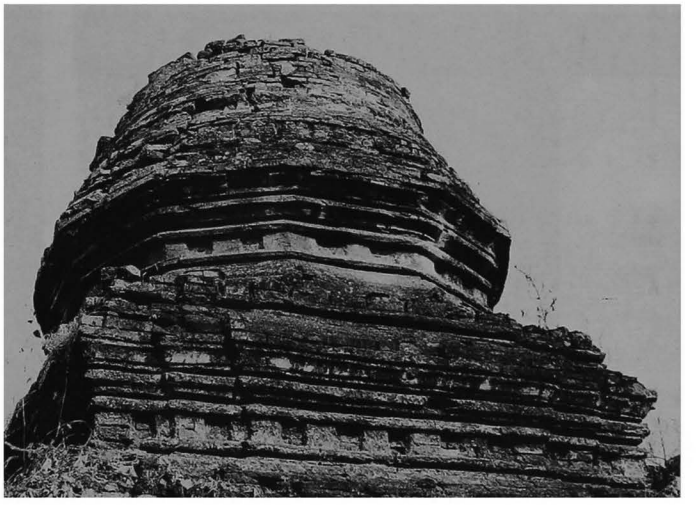
5 present condition
- no maintenance.
- upper parts nearly destroyed.

1523 c - Upper parts, from north-west

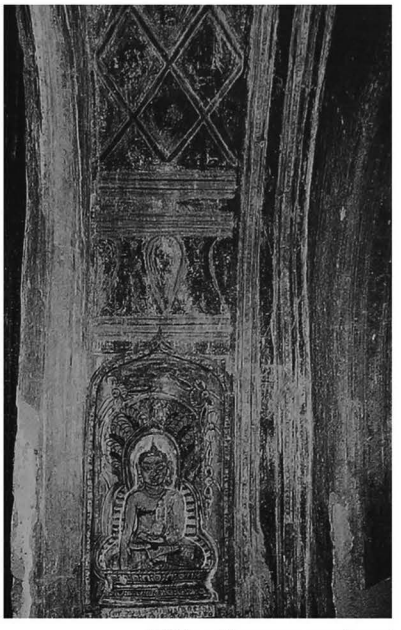
5 present condition
- no maintenance.
- vault over hall partly collapsed.
- upper parts badly damaged and endangered.
- structure badly cracked.

1524 e - Passage, vault and north wall, from south

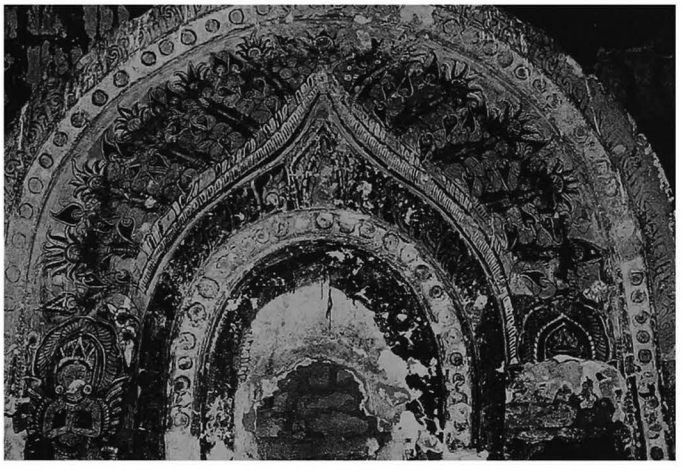
1524 f - Shrine, screen wall, detail of paintings above image

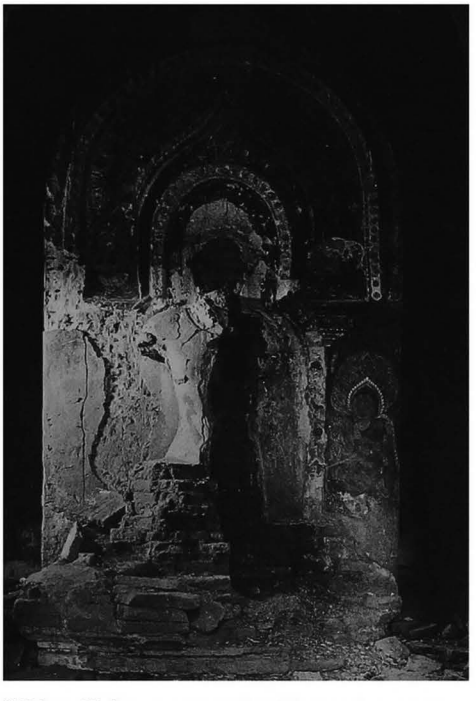
6 image
- 1 seated Buddha, facing east (damaged and headless), against a screen wall.

1524 g - Shrine, screen wall and image, from east

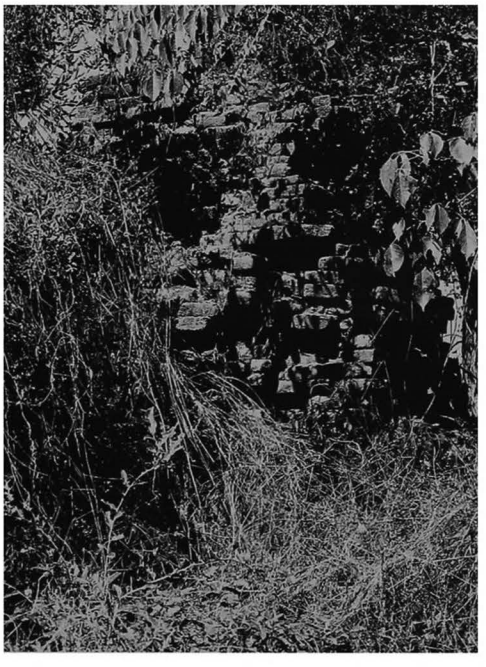
5 present condition
- ruined.
- terraces disintegrated.
- upper parts destroyed.
- present height: 2.40 m.

1526 c - South face, from south-west

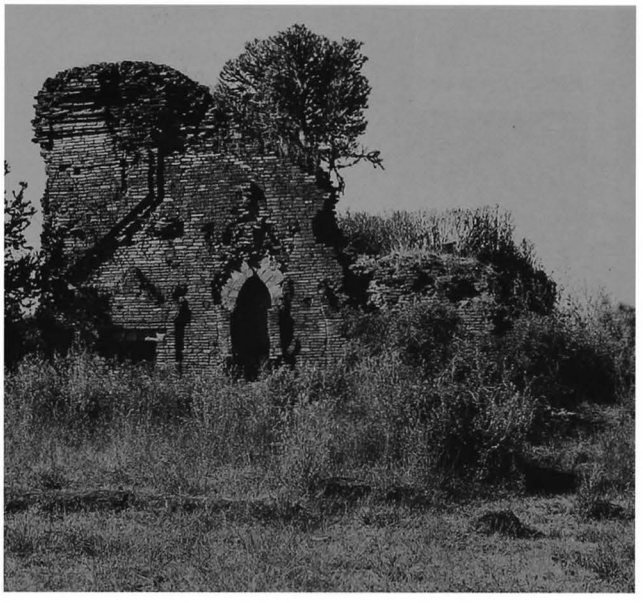
5 present condition
- ruined.
- only part of east wall remains standing.
- ground floor buried under debris.

1527 c - South face

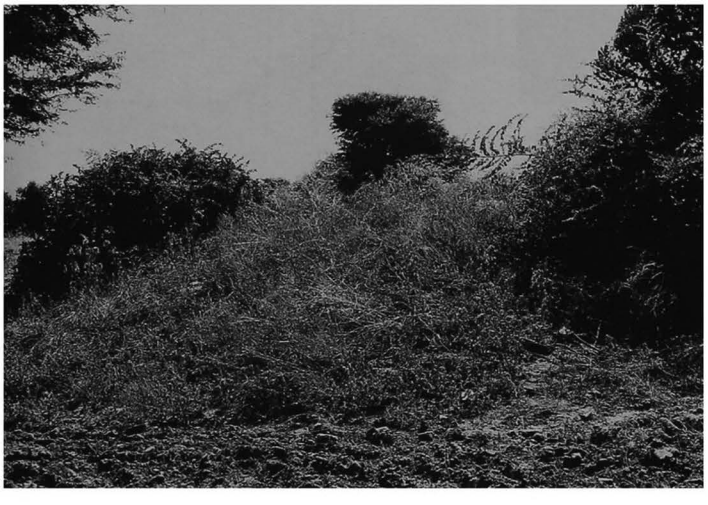
5 present condition
- brick debris.
- height: approx. 1.80 m.

1528 b - From west

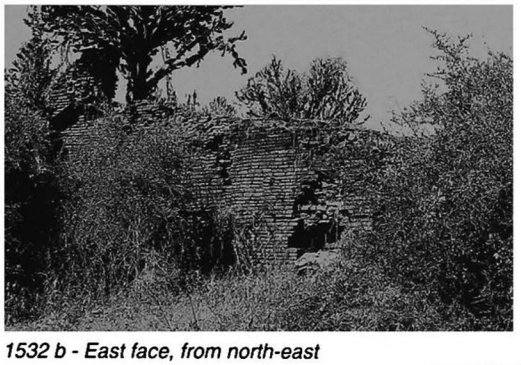
5 present condition
- ruined.
- only base of walls remains.
- ground floor buried under debris.

1532 b - East face, from north-east

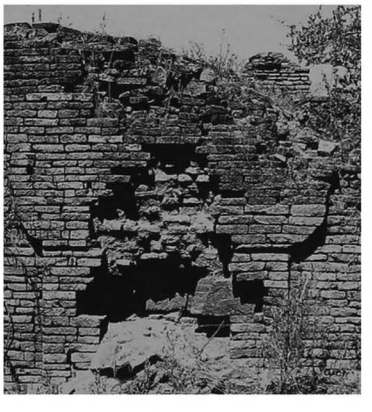
1532 c - East face, detail of north window

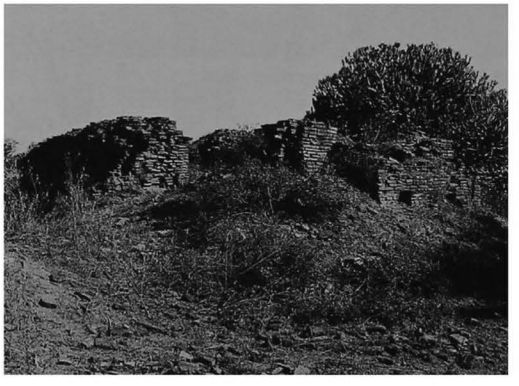
5 present condition
- ruined.
- only base of walls remains.
- vaults and upper parts collapsed.
- ground floor buried under debris.

1533 b - East face, forepart, north side

1533 c - From south-west

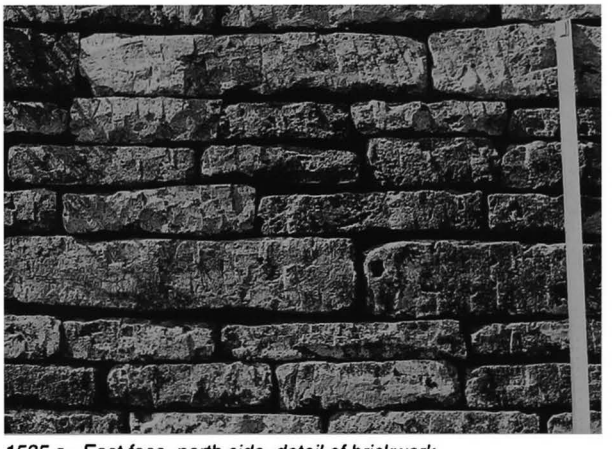
1535 c - East face, north side, detail of brickwork

5 present condition
- ruined.
- only south-east corner remains standing.
- ground floor buried under debris.

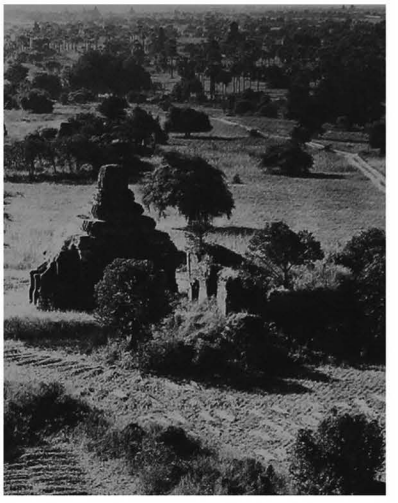
1536 b - From north, together with 1535

5 present condition
- regularly maintained.
- east porch collapsed.
- brick grilles built by Arch. Dept.

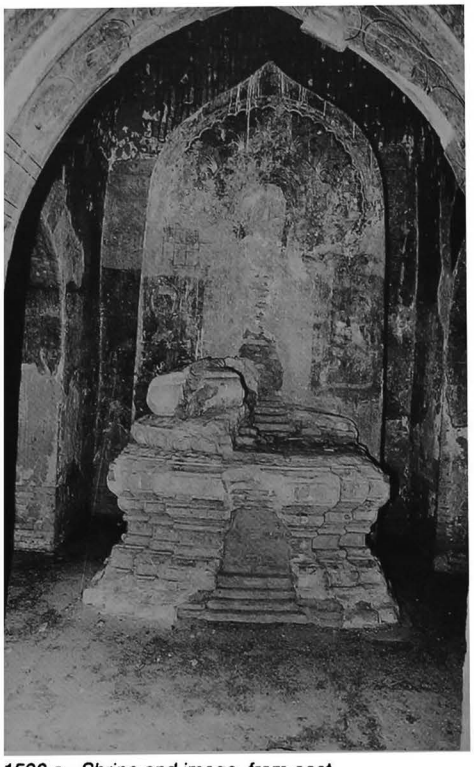
1536 e - Shrine and image, from east

6 image
- 1 seated Buddha, against a screen wall, facing east (leg only remains).

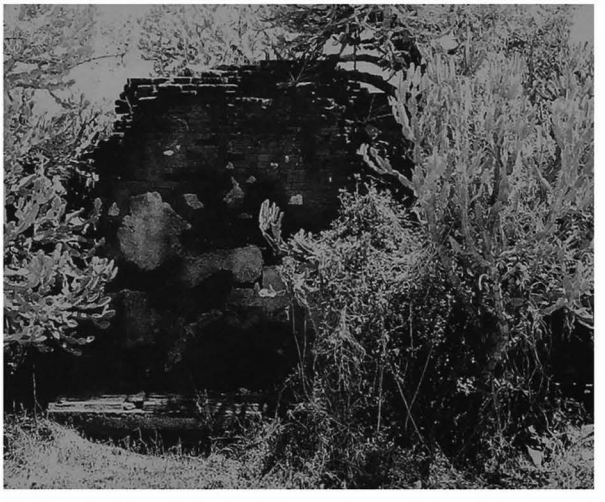
1538 c - South face

5 present condition
- ruined.
- vaults and upper parts collapsed.
- ground floor buried under debris.

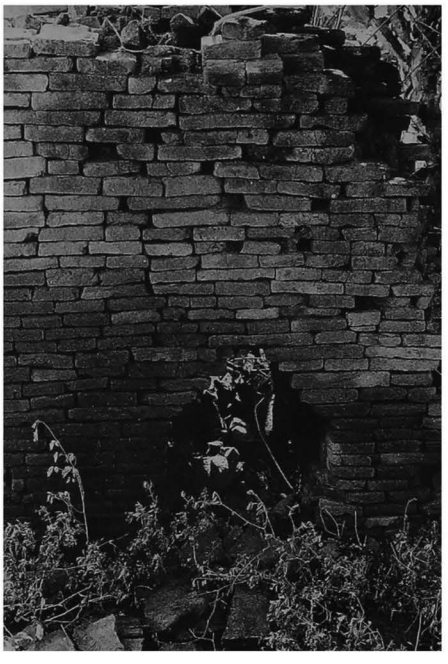
1541 c - East wall, west face, detail

5 present condition
- brick and stone debris.
- height: approx. 1.60 m.

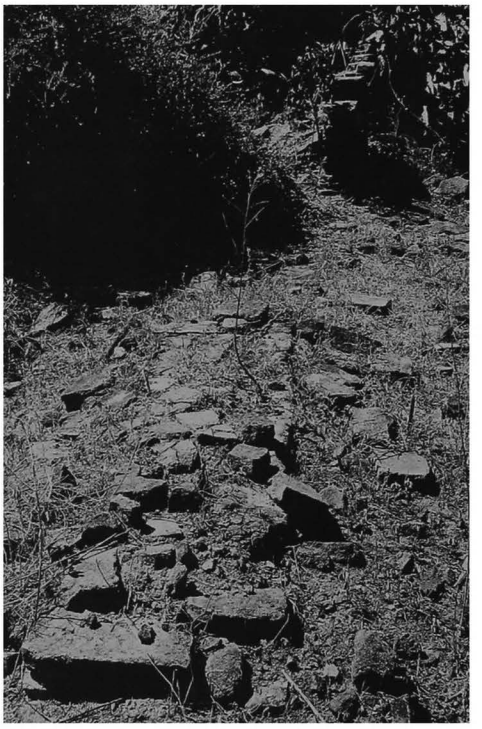
1543 c - From north

5 present condition
- brick debris.
- height: approx. 1.60 m.

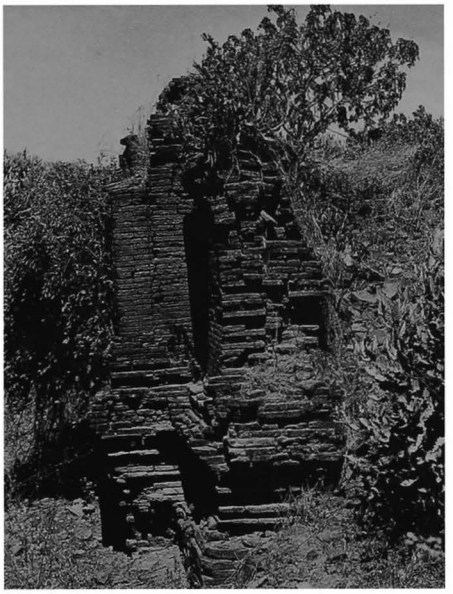
1546 b - East face, south-east corner

5 present condition
- ruined.
- only parts of wall remain.
- vaults and upper parts collapsed.
- ground floor buried under debris.

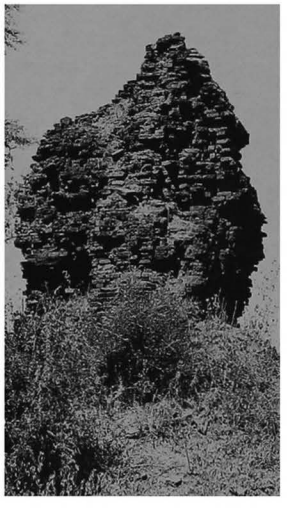
1547 c - From south-west

5 present condition
- half-ruined.
- base and terraces disintegrated.
- upper parts destroyed.

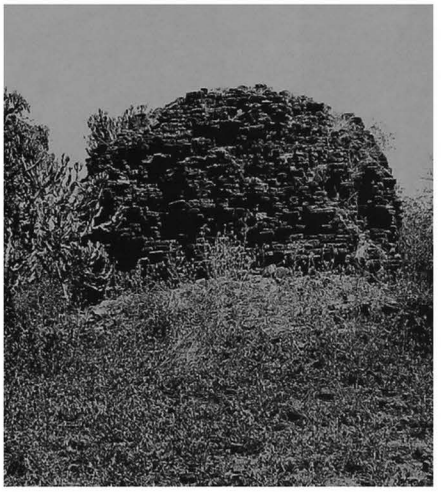
1549 c - West face, from south-west

5 present condition
- ruined.
- base and terraces disintegrated.
- upper parts destroyed.

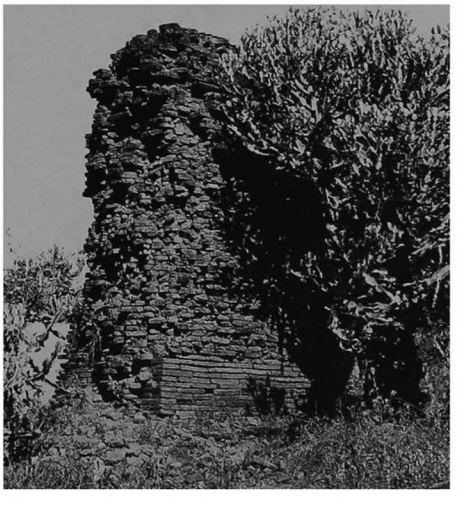
1550 c - From north-west

5 present condition
- ruined.
- base and terraces disintegrated.
- upper parts destroyed.

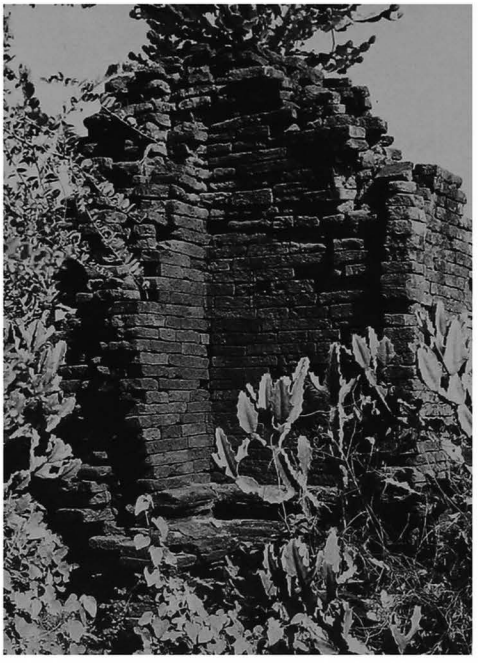
1551 c - From south-west

5 present condition
- ruined.
- vaults and upper parts collapsed.
- ground floor buried under debris.

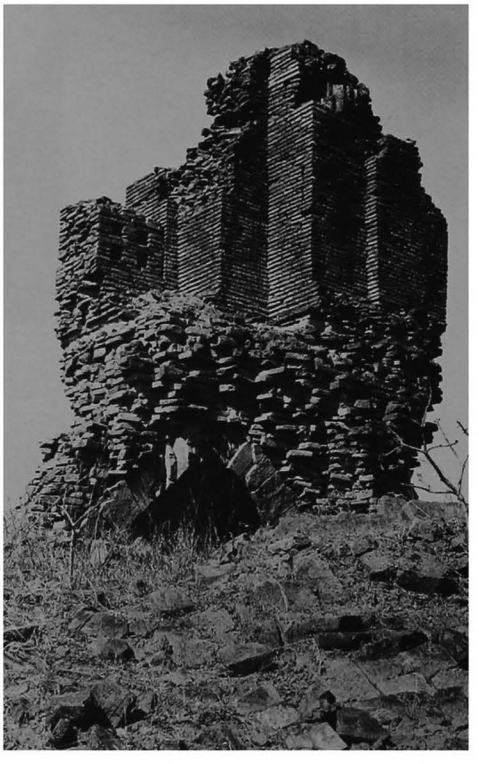
1557 d - From south (1995)

5 present condition
- ruined.
- vaults partly destroyed.
- ground floor buried under debris.
- upper part destroyed by the 1975 earthquake.

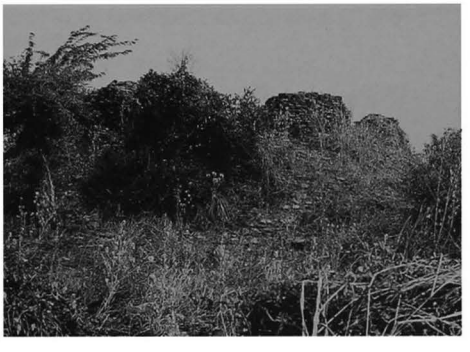
1562 c - North-east corner, from north-east

5 present condition
- ruined.
- no more trace of vaults.
- ground floor buried under debris.

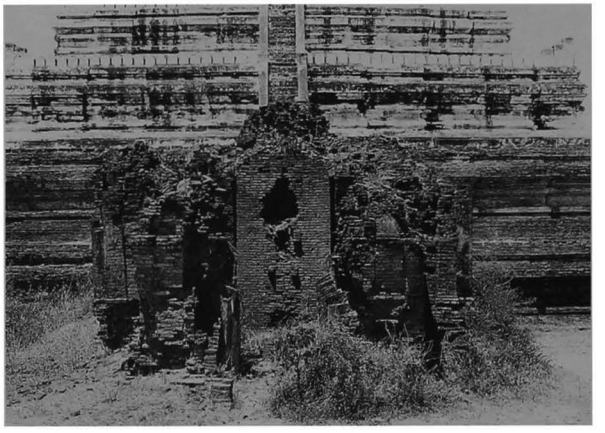
1566 b - East face, together with 1568 Shwe-hsan-daw

5 present condition
- ruined.
- vaults and upper parts collapsed.
- walls badly cracked.
- ground floor cleared of debris.

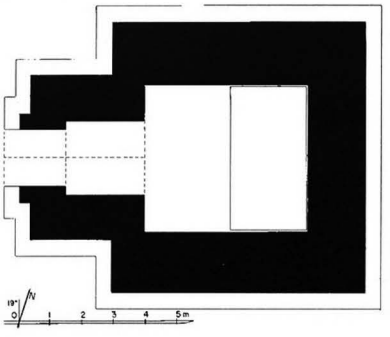
1569 a - Plan

5 present condition
- half-ruined.
- vault and upper parts collapsed.
- structure badly cracked.
- tested for bore drilling and grout injections by Y.I.T. after the 1975 earthquake.

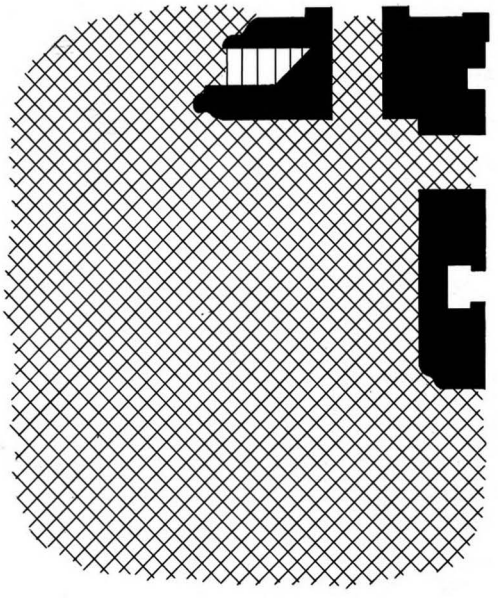
1572 a - Plan

5 present condition
- ruined.
- walls and vault collapsed.
- only north-east corner remains.
- ground floor buried under debris.

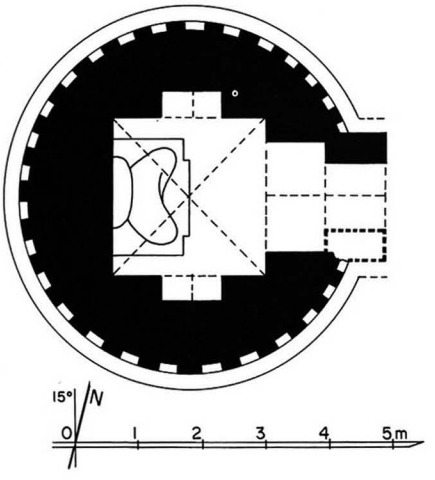
1573 a - Plan

5 present condition
- east vestibule and porch collapsed.
- upper parts badly damaged.
- repaired (Arch. Dept) 1991.

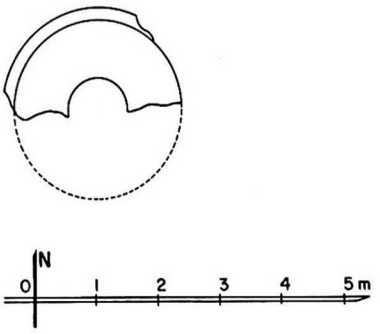
1574 a - Plan

5 present condition
- ruined.
- base and terraces disintegrated.
- upper parts destroyed.
- present height: approx. 2.00 m.

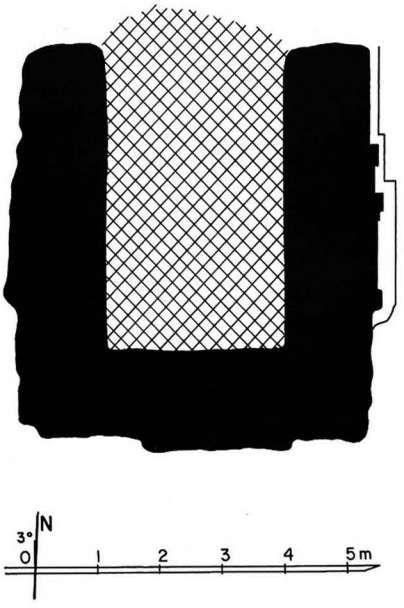
1576 a - Plan

5 present condition
- ruined.
- facing disintegrated.
- vaults and upper parts collapsed.
- ground floor buried under debris.
